## **Limited Visual Dam Safety Inspection Summary Report**

**MA-079**

**Reservoir 52**

**May 2006**

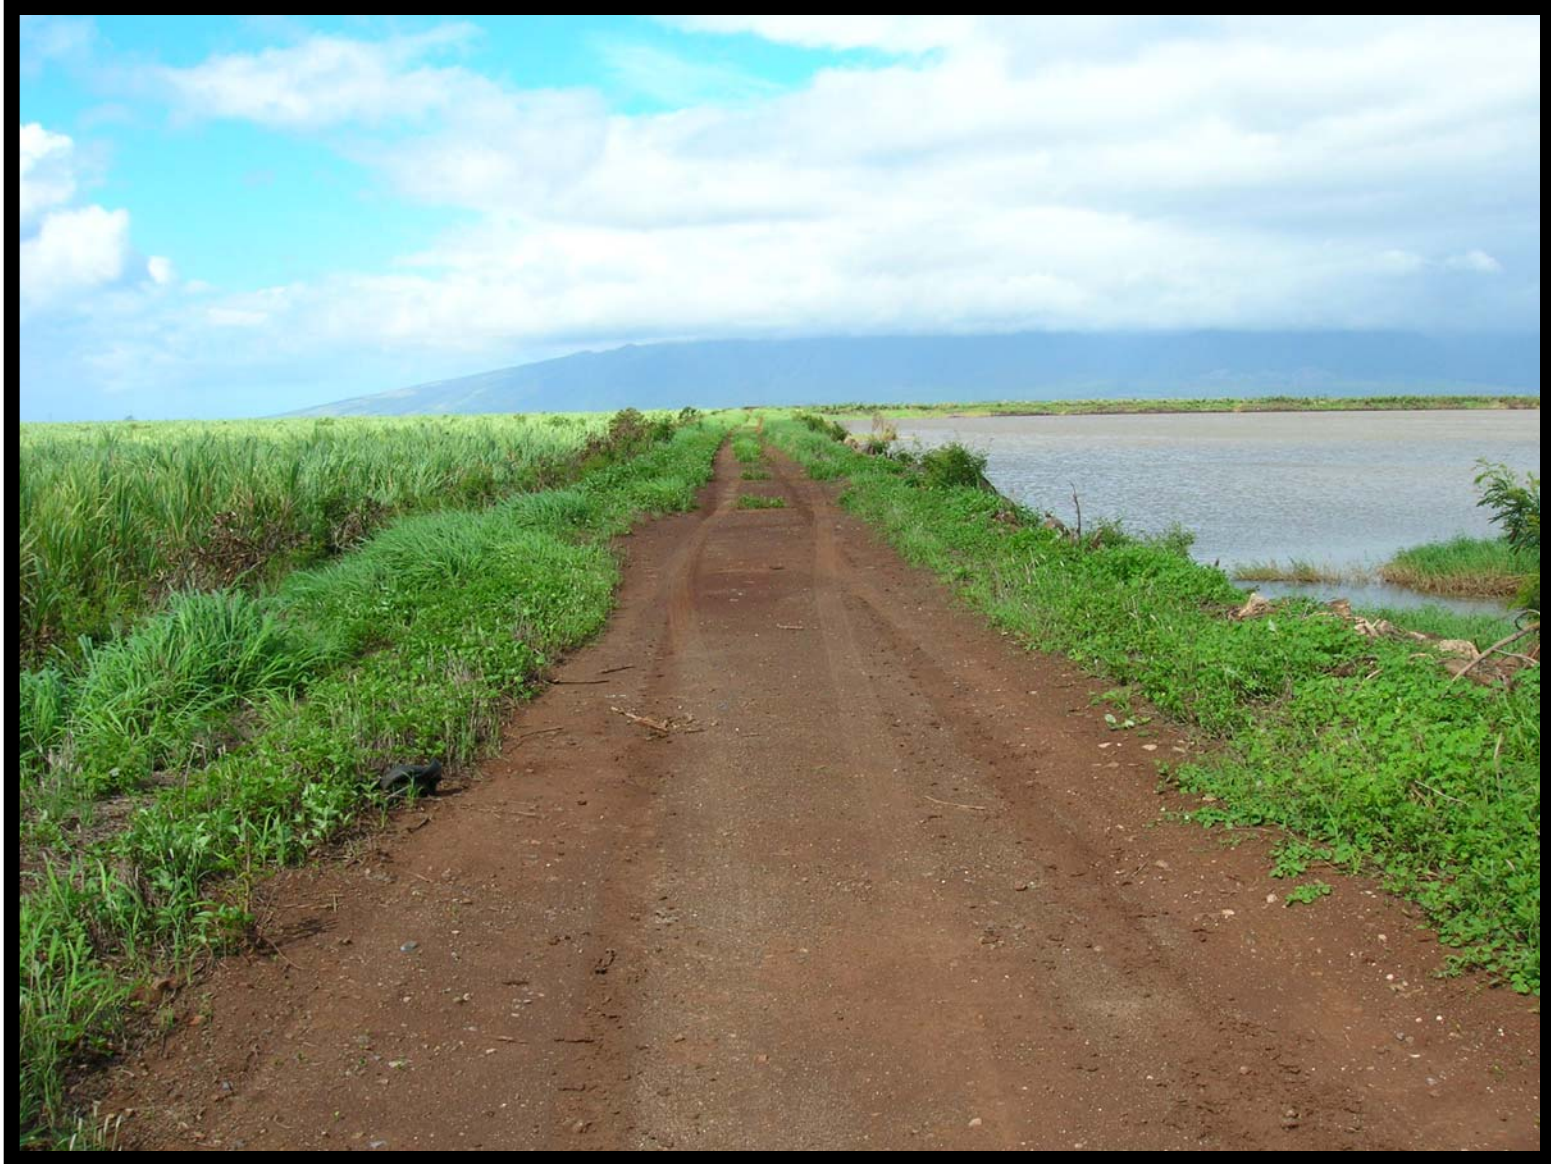
Cracks were not visible, however the crest was not entirely visible.

Heavy vegetation was observed on the edges of the crest. These were primarily small woody vegetation and high grass.

- a. The dam crest appeared to be in fair to poor condition and requires corrective action.
- b. Portions of the crest were not visible due to high grass and bush vegetation. Clear high vegetation and maintain low to enable easy visual inspection.
- c. Tree(s) were observed along the dam crest. Trees have been identified as the probably cause of piping failures, and can possibly cause sever damage to the embankment if they are uprooted during a high winds. Corrective action is required to remove the tree hazards from the dam. Acceptable remedies include removal of the tree and its root structure down to a 2" diameter and reconstructing the damaged embankment section. All repair work shall be accomplished as per the requirements of licensed geotechnical or structural engineer. Routinely monitor the damaged area for signs of settlement and seepage.

079 Crest

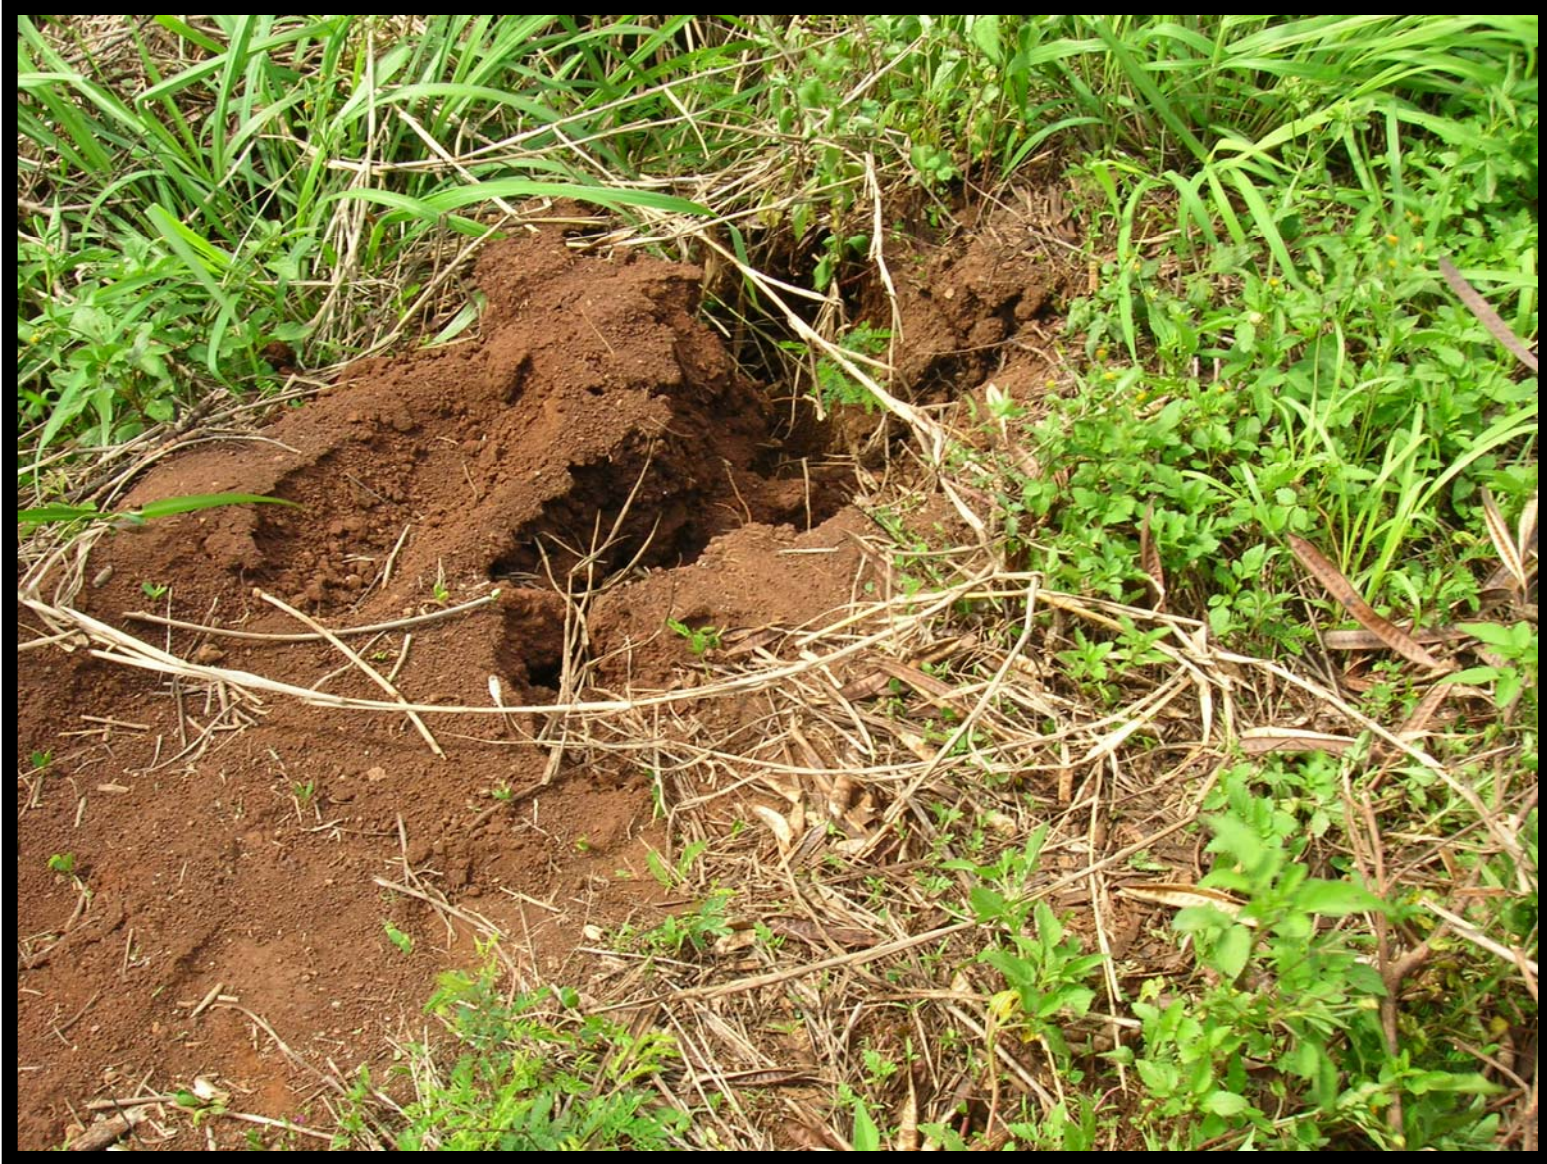
079 crest erosion

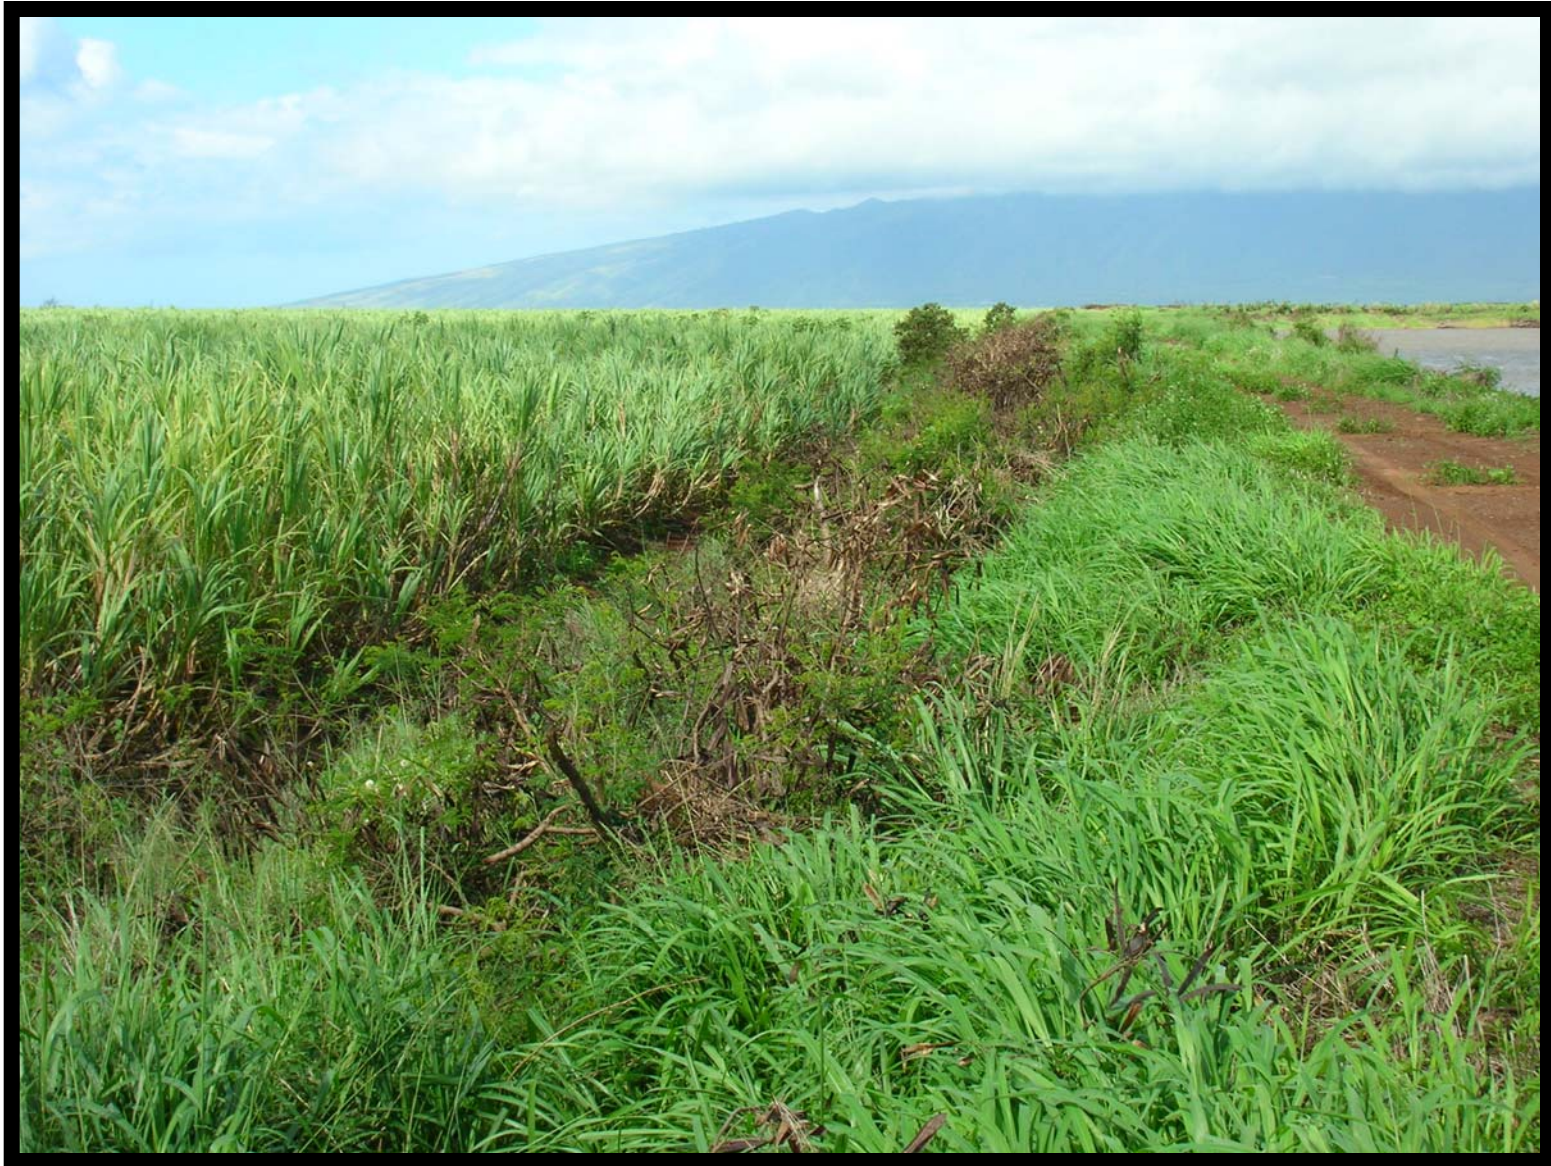
The downstream slope was in fair to poor condition and not visible due to heavy vegetation. The slope was very steep, around a 1 to 2 slope.

There was no slope protection observed on the downstream slope.

Vegetation was observed on the downstream slope. The majority of the vegetation was woody trees ranging from 2" to 2 feet in diameter.

- a. The downstream slope appeared to be in fair to poor condition and requires corrective action.
- b. The down stream slope was not visible due to high grass and bush vegetation. Clear high vegetation and maintain low to enable easy visual inspection.
- c. Tree(s) were observed on the downstream slope. Trees have been identified as the probably cause of piping failures, and can possibly cause sever damage to the embankment if they are uprooted during a high winds. Corrective action is required to remove the tree hazards from the dam. Acceptable remedies include

079 downstream slope

removal of the tree and its root structure down to a 2" diameter and reconstructing the damaged embankment section. All repair work shall be accomplished as per the requirements of licensed geotechnical or structural engineer. Routinely monitor the damaged area for signs of settlement and seepage.

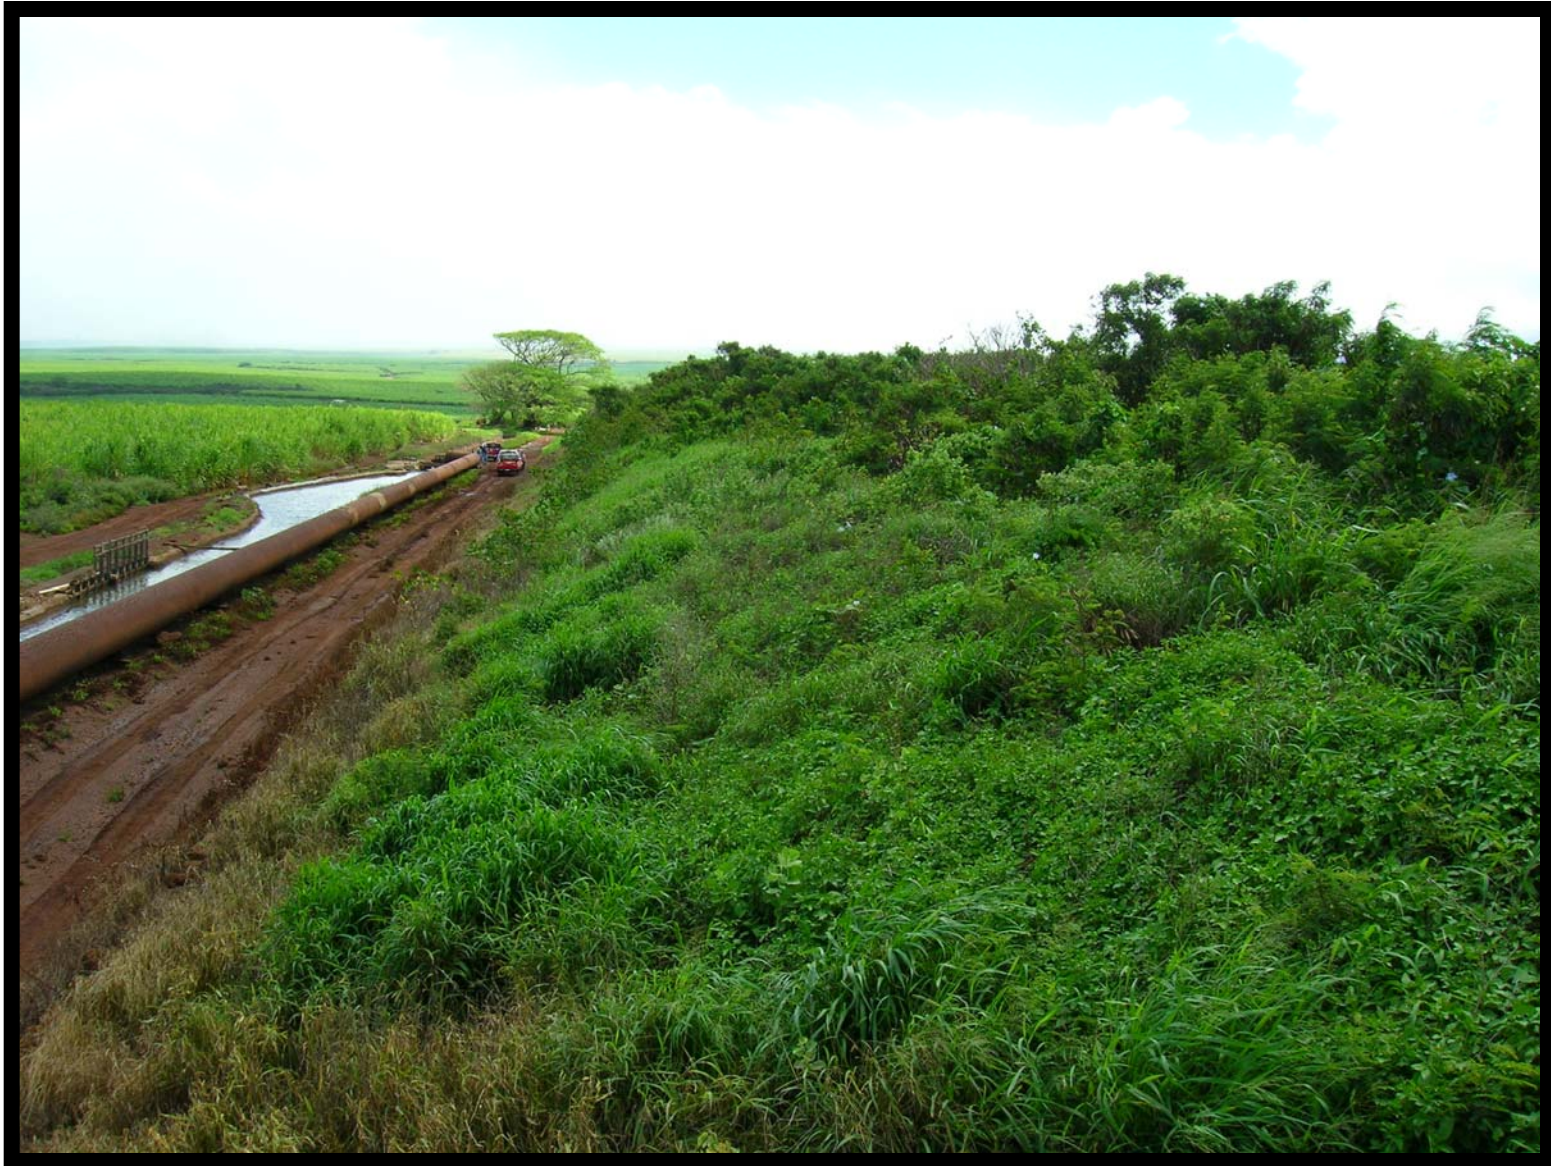
079 downstream slope 2

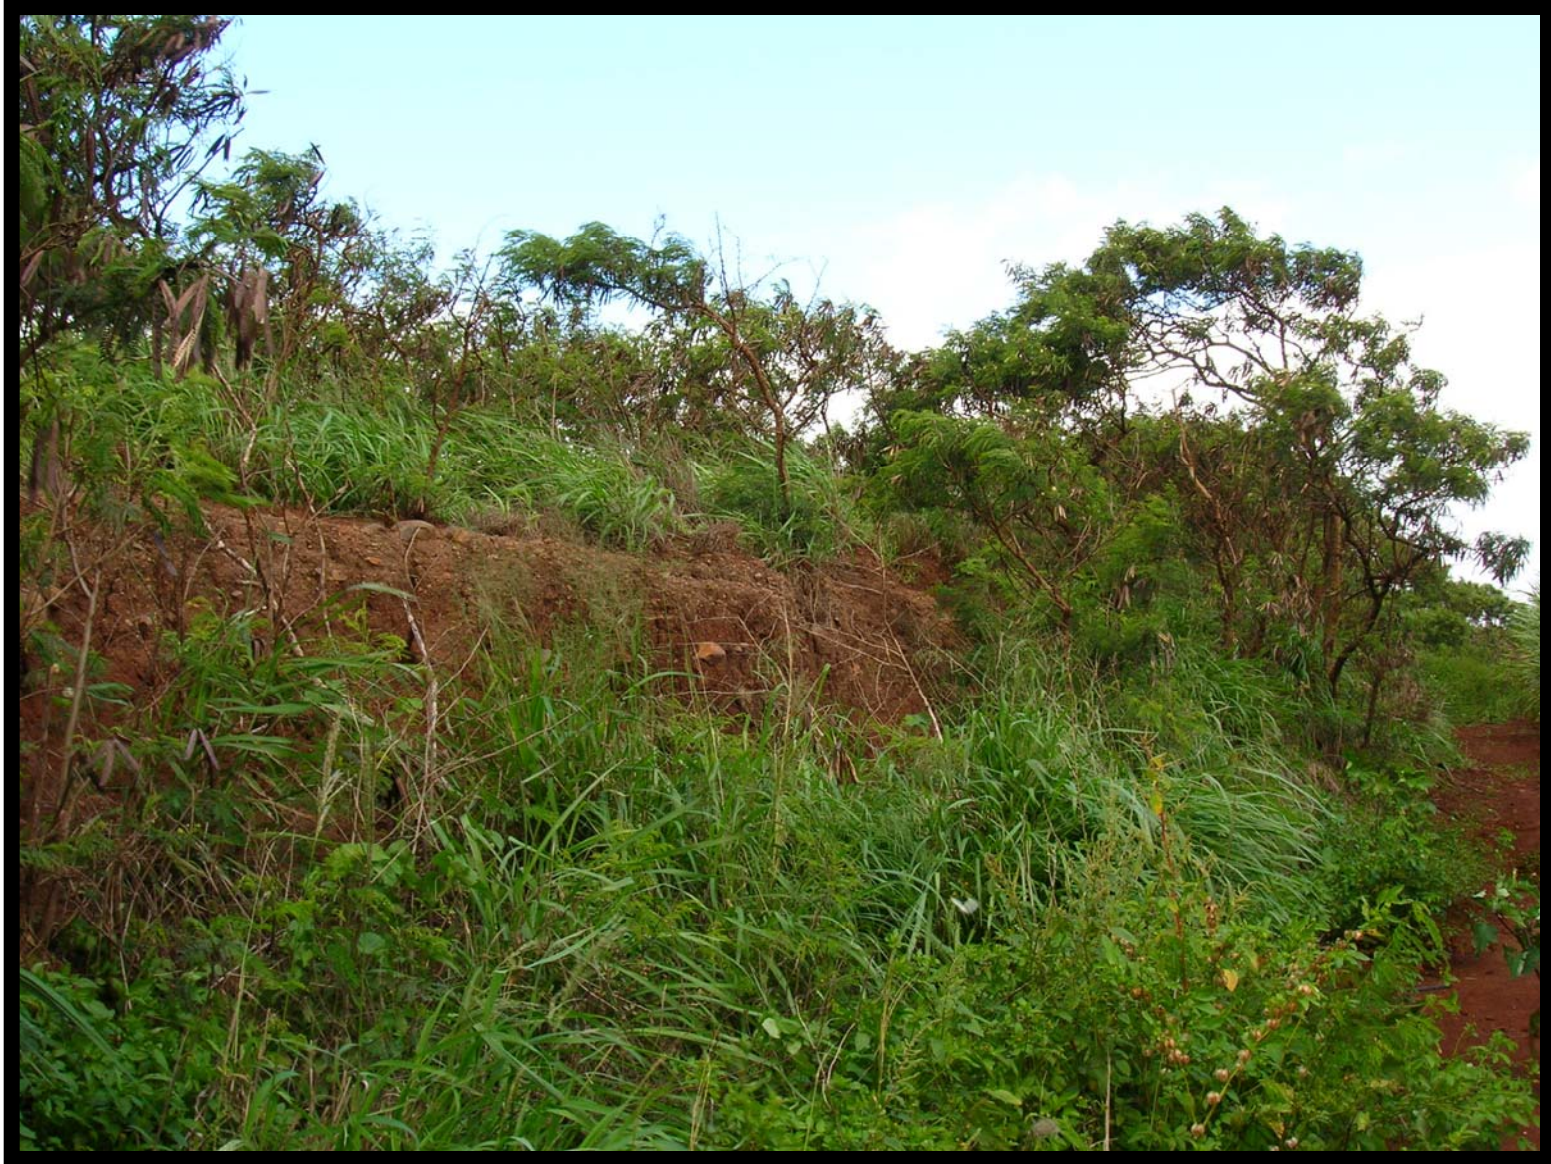
079 downstream slope cut

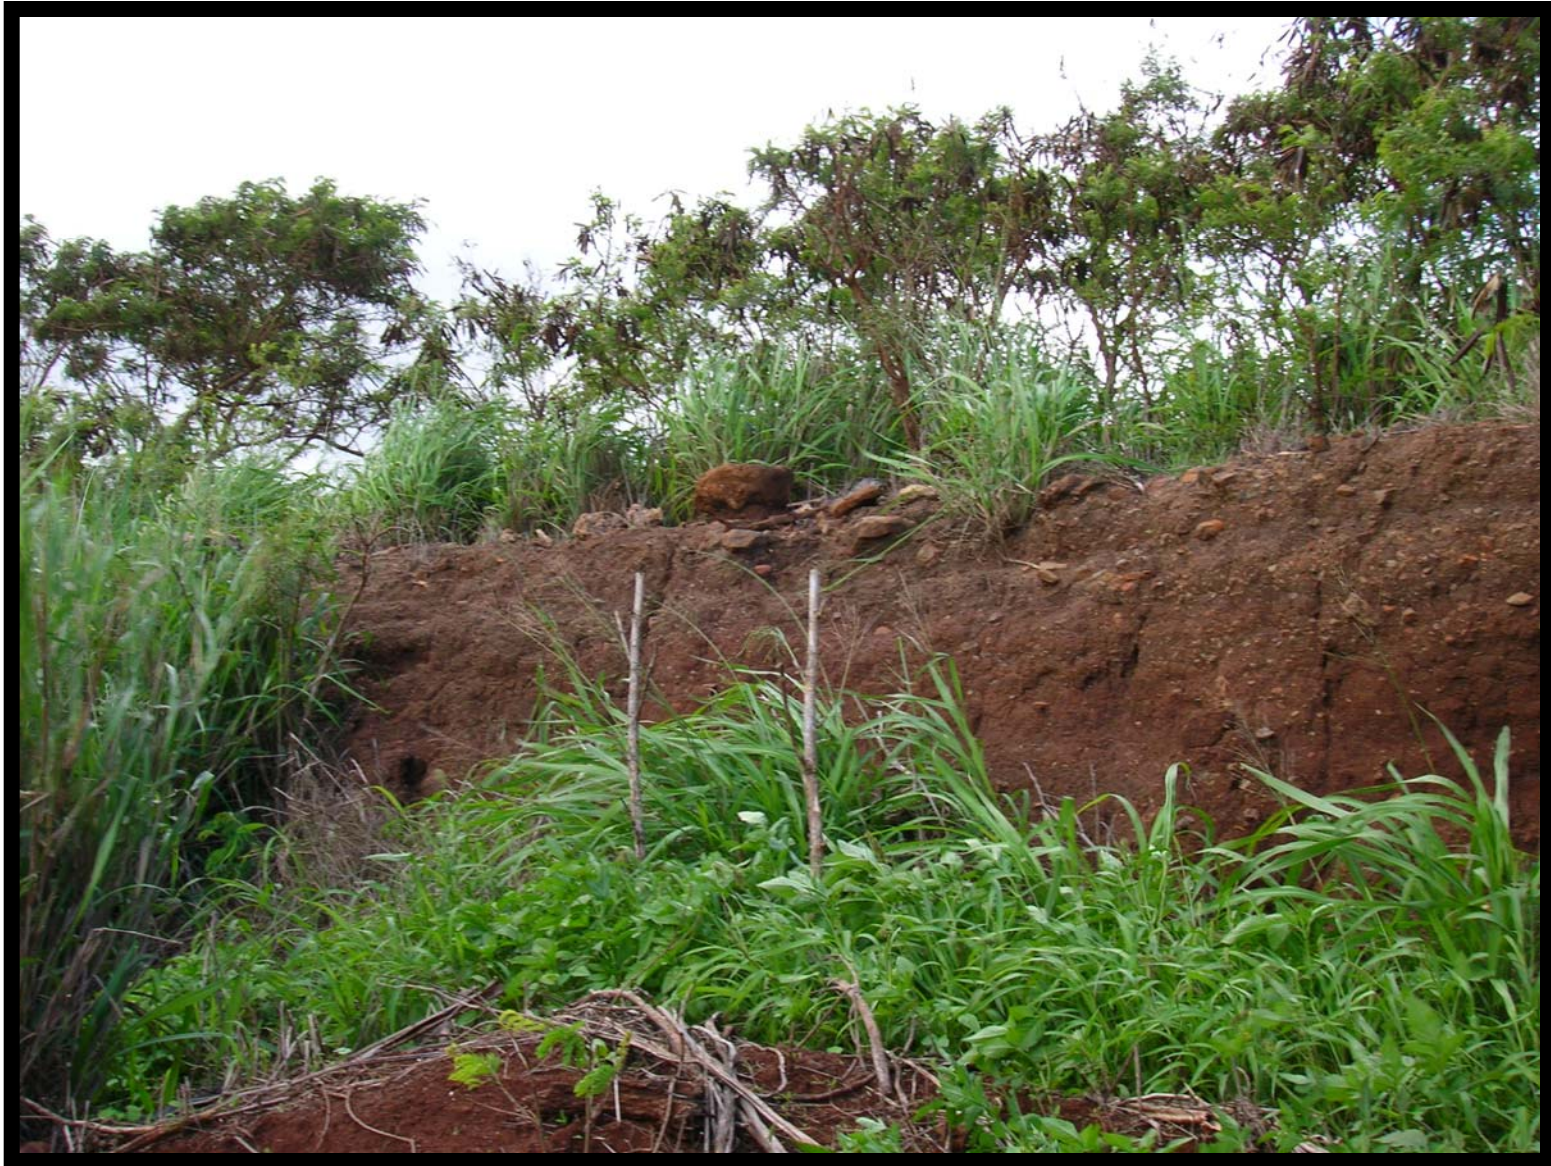
079 downstream slope cut 2

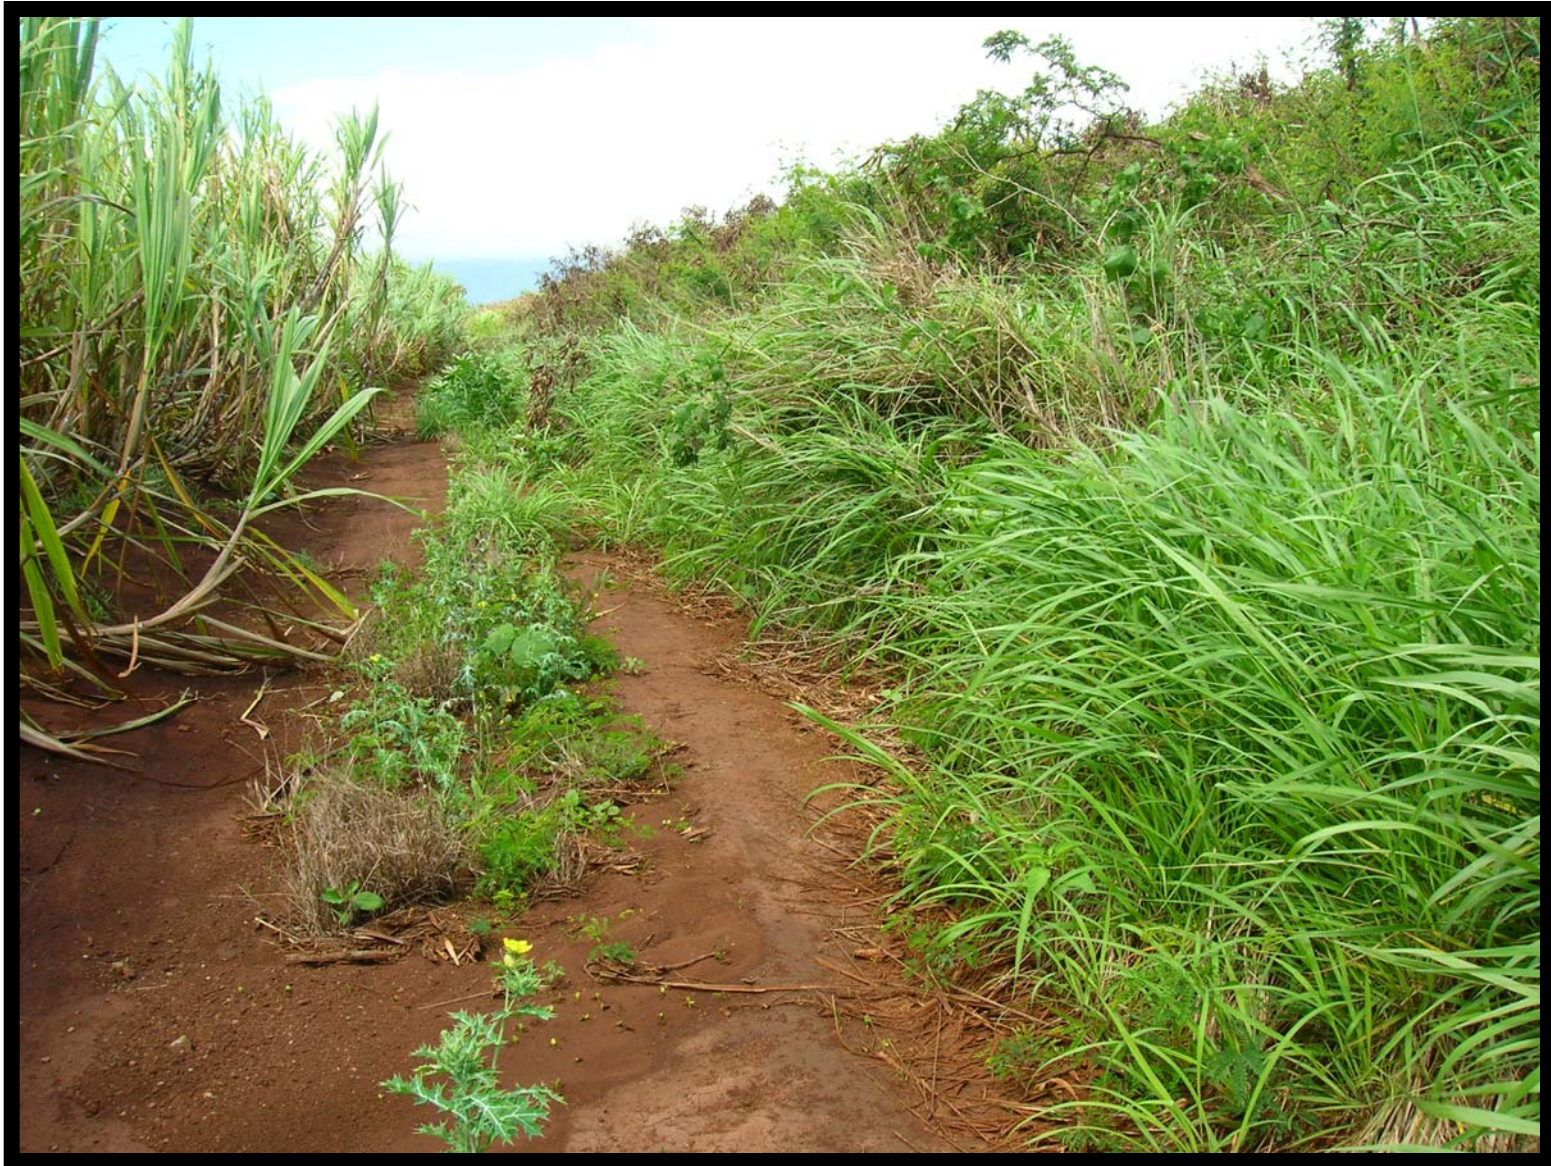
Areas were noted along the toe that could be possible seepage spots. These locations were observed near. The water that was seeping appeared to be moving relatively fast and seemed to be moving some materials.

- a. The abutments/toe were not inspected.
- b. The abutments/toe appeared to be in fair to poor condition and requires corrective action.
- c. The abutment/toe area was not visible due to high grass and bush vegetation. Clear high vegetation and maintain low to enable easy visual inspection.

079 downstream toe

- d. Tree(s) were observed along the abutment/toe. Trees have been identified as the probably cause of piping failures, and can possibly cause sever damage to the embankment if they are uprooted during a high winds. Corrective action is required to remove the tree hazards from the dam. Acceptable remedies include removal of the tree and its root structure down to a 2" diameter and reconstructing the damaged embankment section. All repair work shall be accomplished as per the requirements of licensed geotechnical or structural engineer. Routinely monitor the damaged area for signs of settlement and seepage.

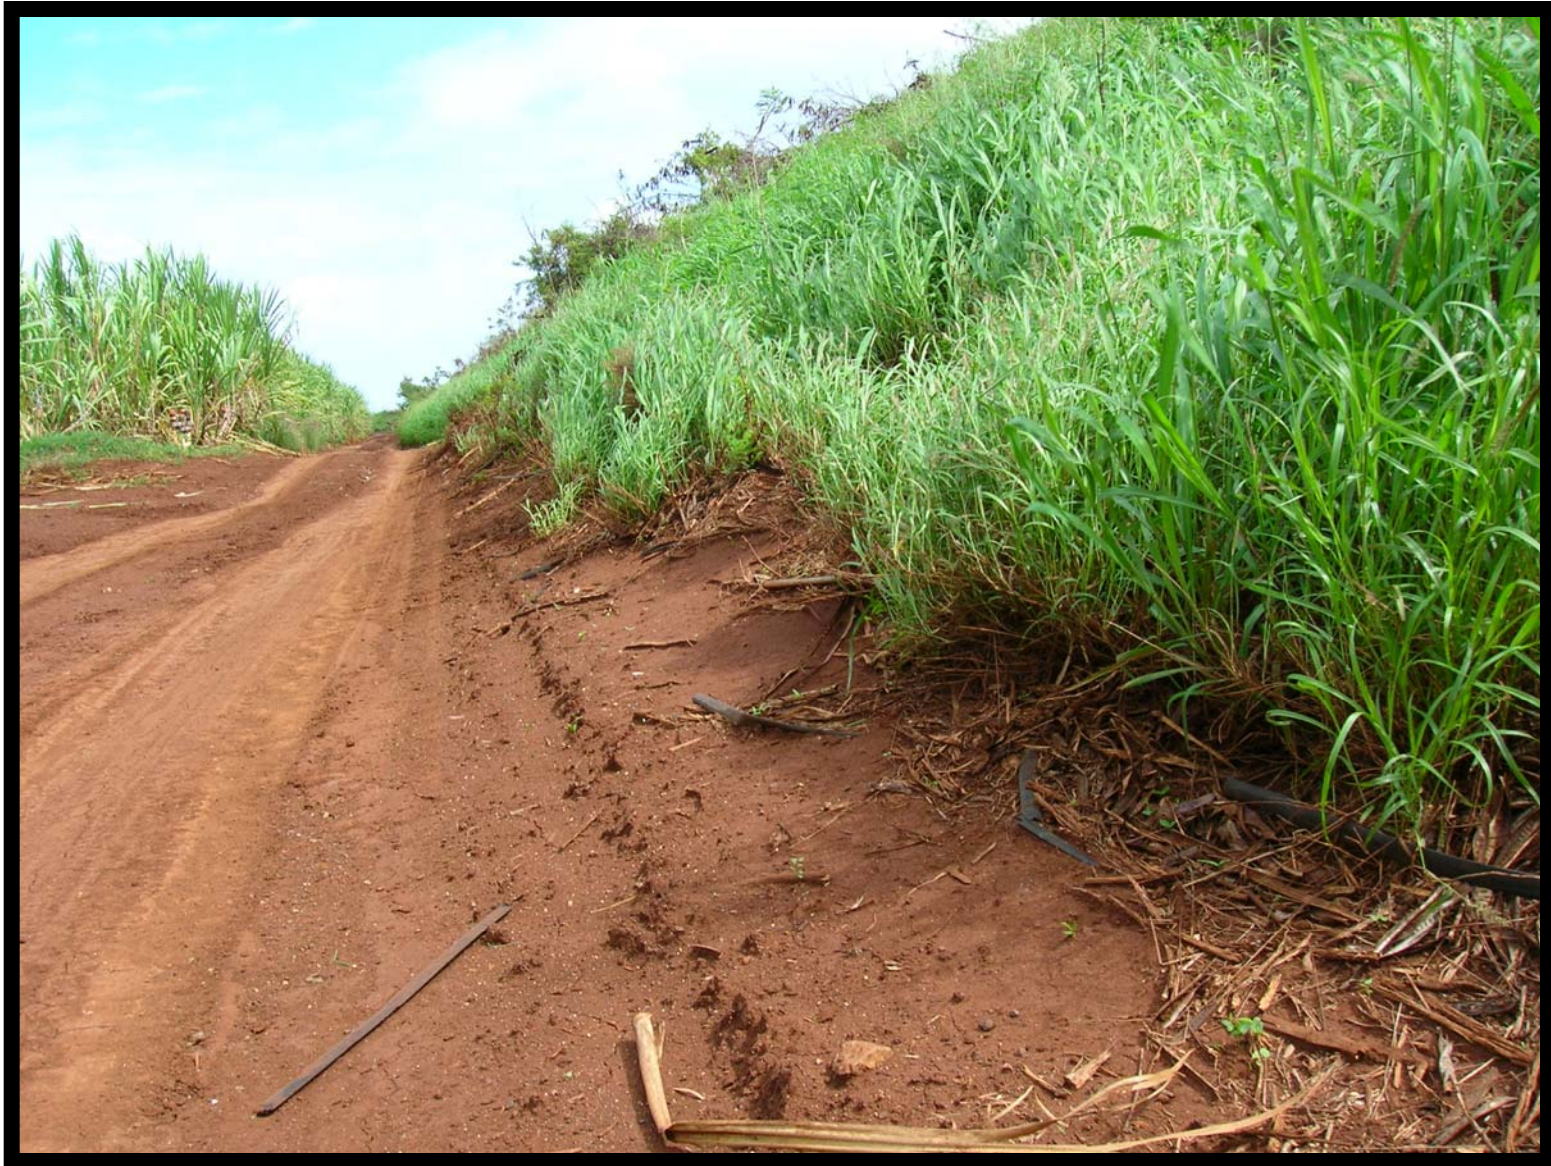
079 downstream toe 2

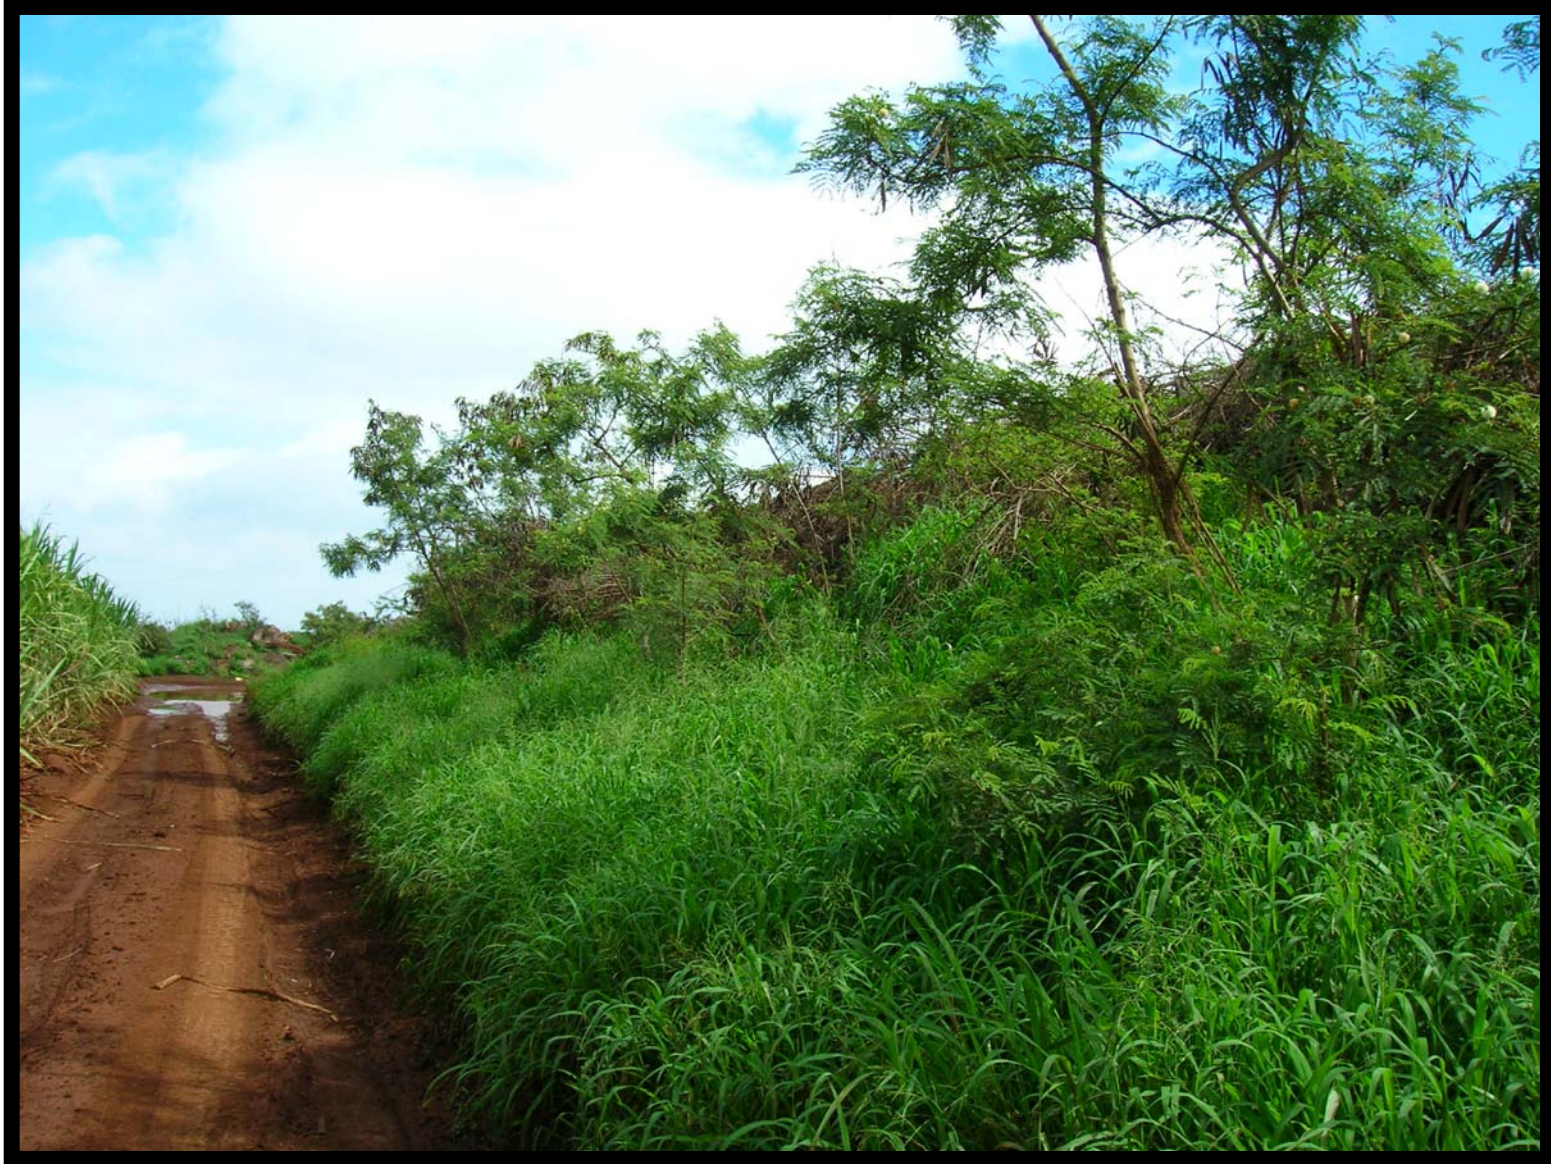
079 downstream toe 3

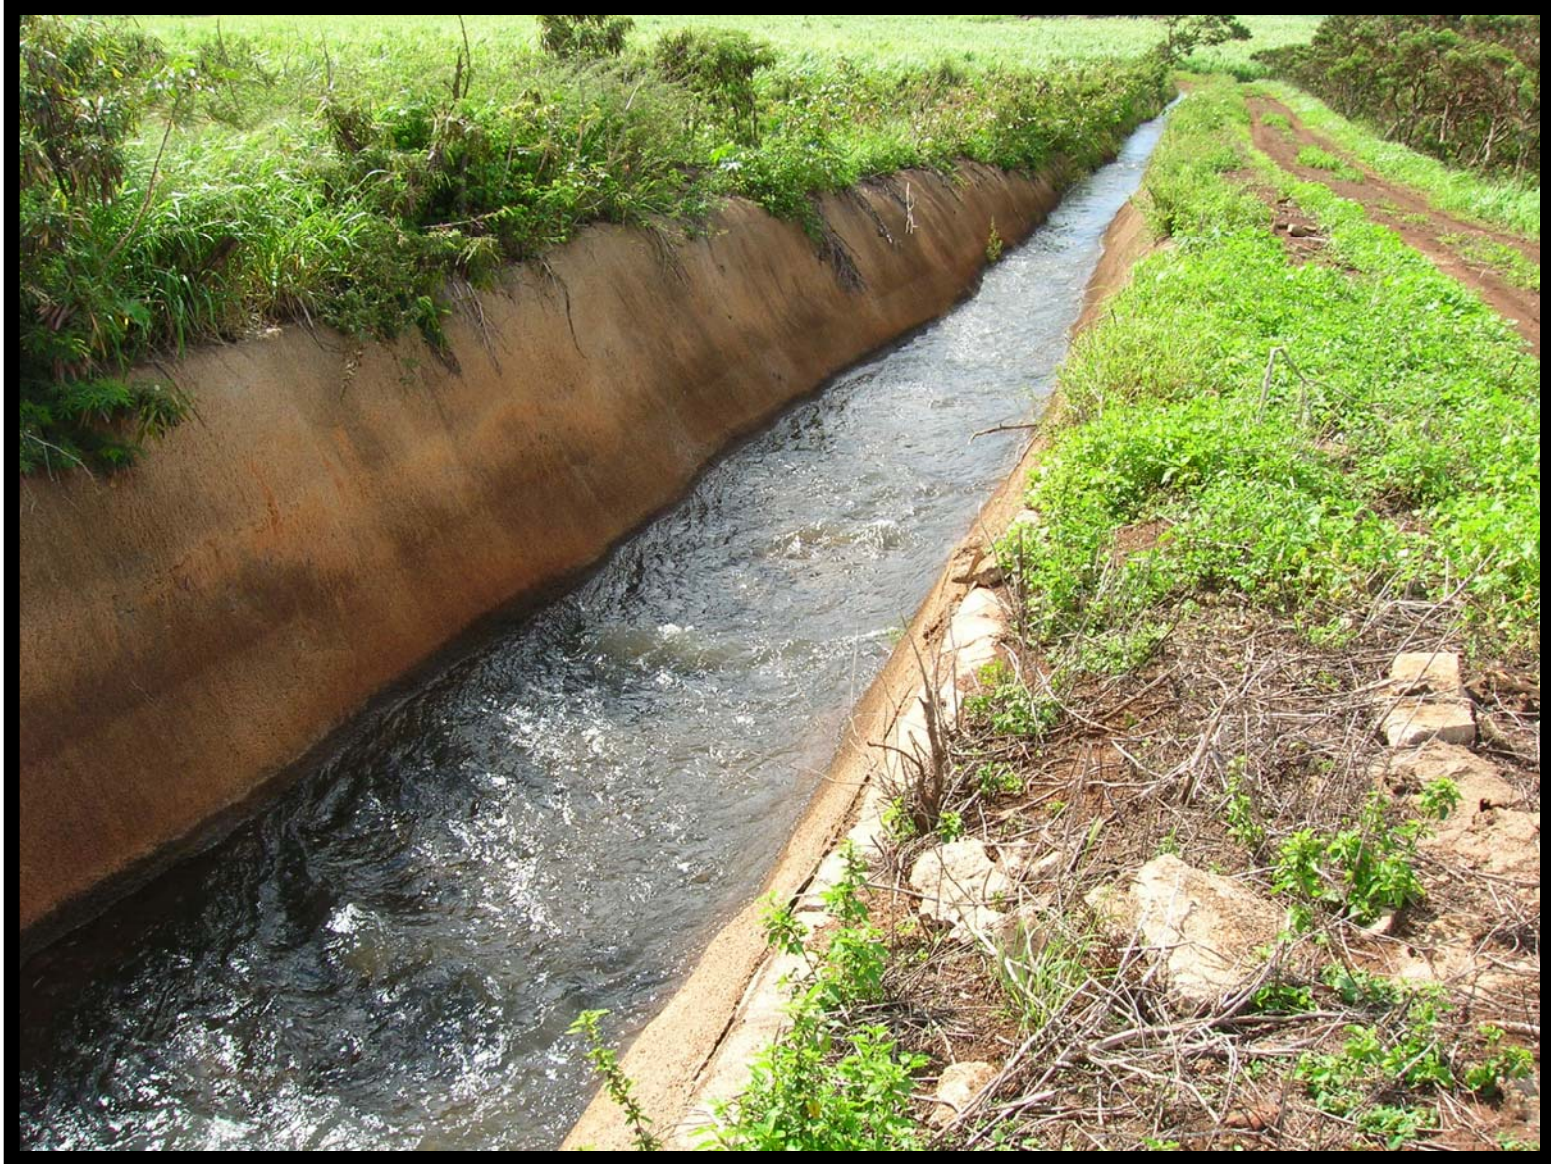
- a. The intake works were not tested.
- b. The intake works appeared to be in satisfactory condition, no corrective actions are required at this time.

079 inlet

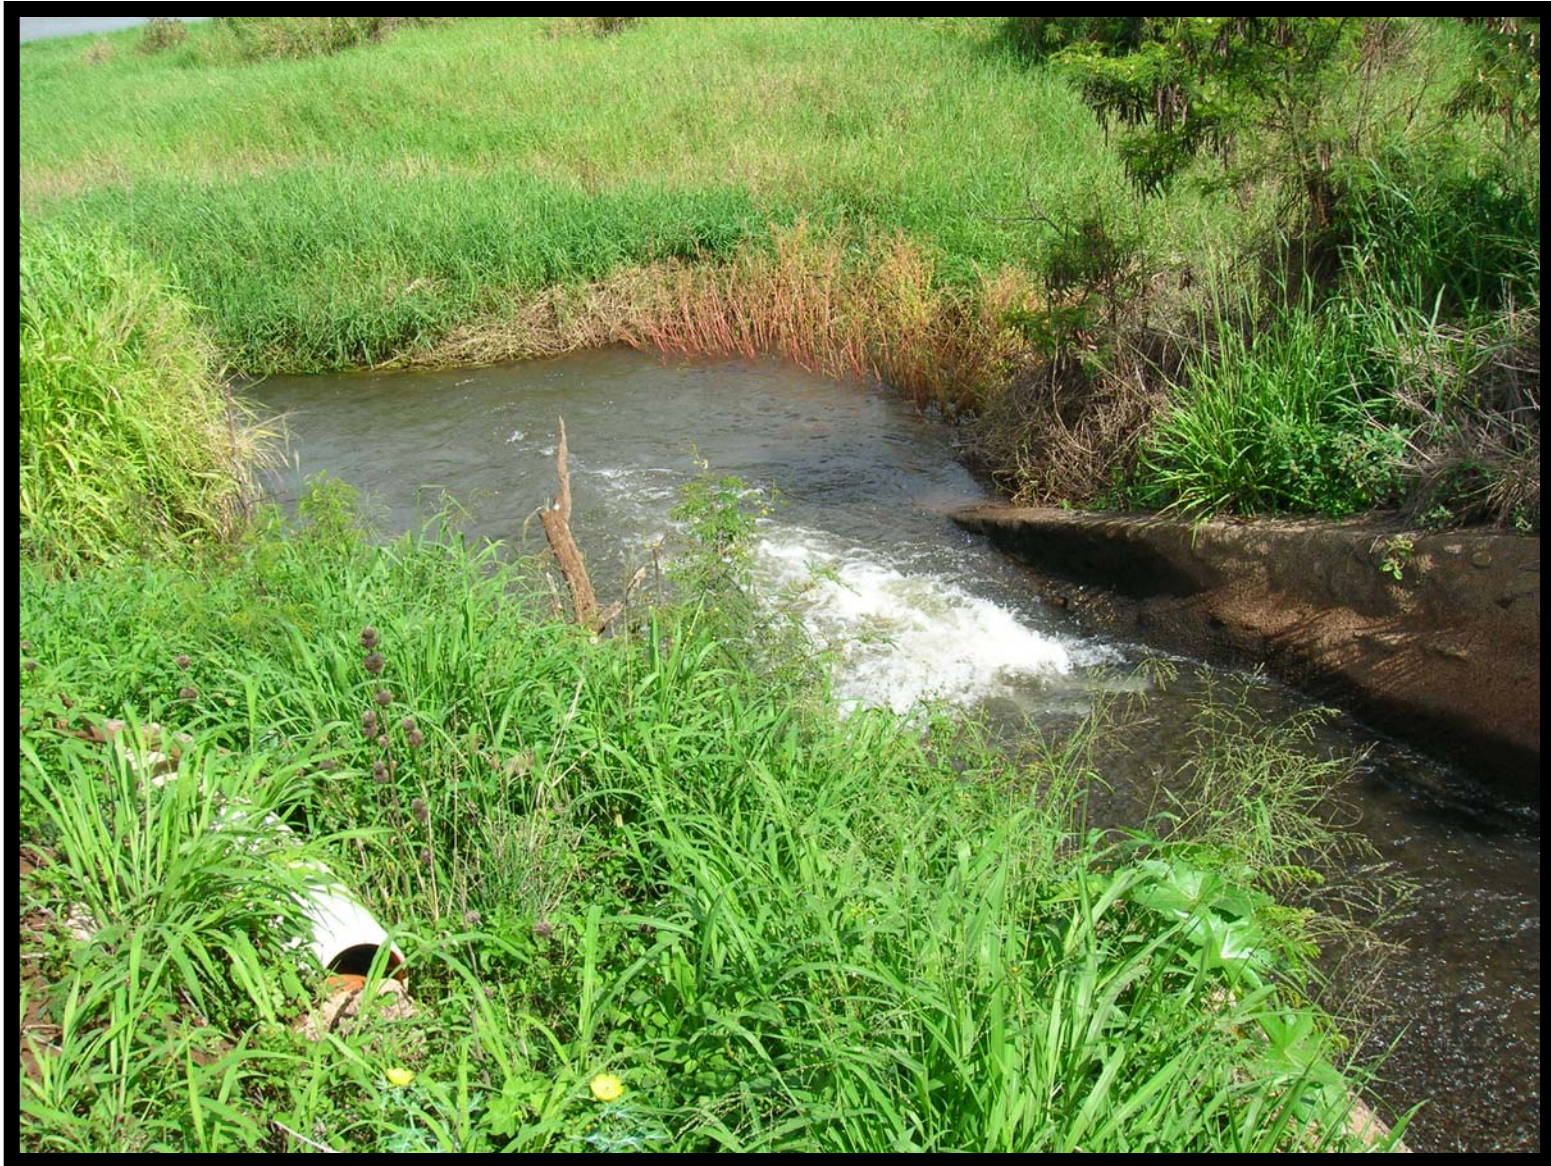
079 inlet 2

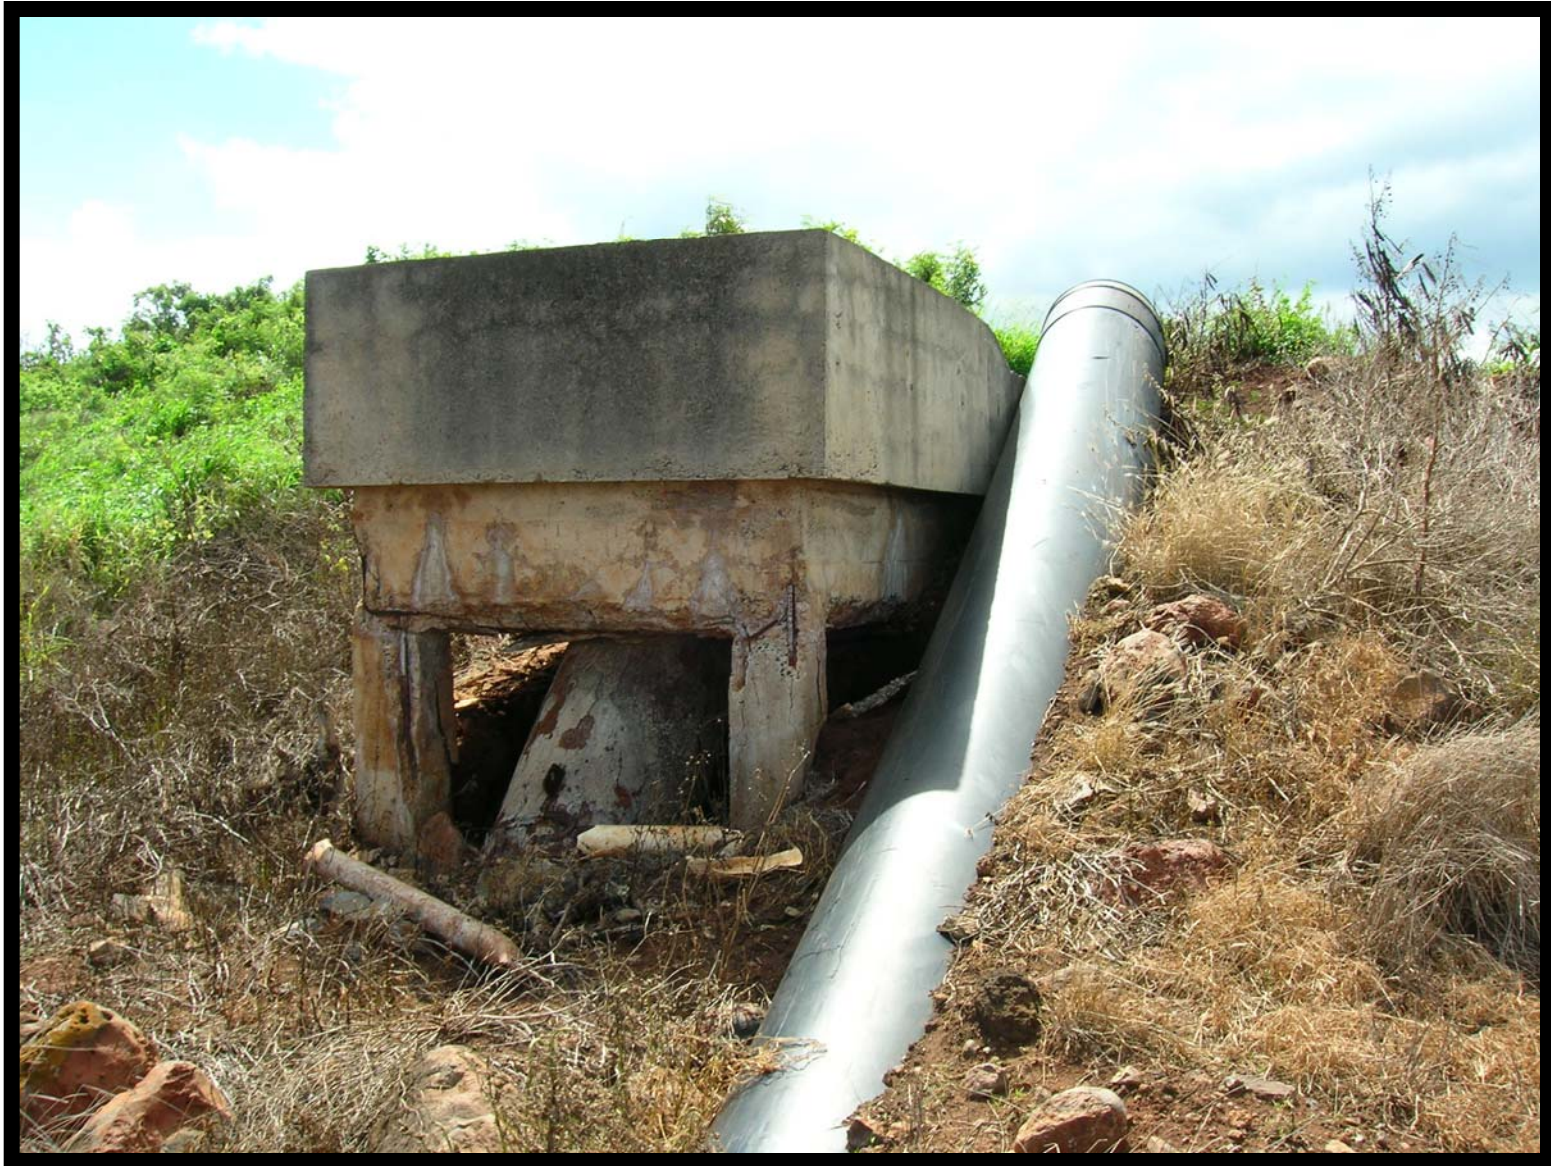
- b. The outlet works appeared to be in satisfactory condition, no corrective actions are required at this time.

079 outlet works
